# Manhole Inspection Summary

Manhole # S31GG\_011MH

Record Plat: **31GG** Node: **011** Status: **Found**

**Location** Address: **BREVARD ST**

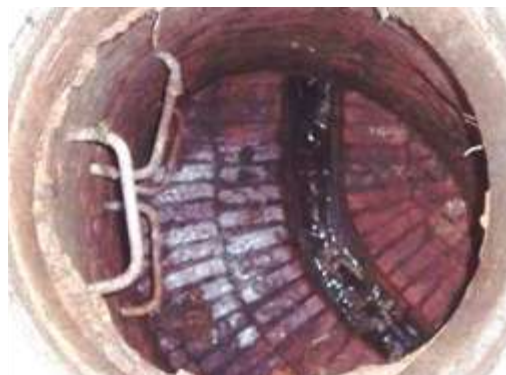
Top View

Bench debris. Corroded steps.

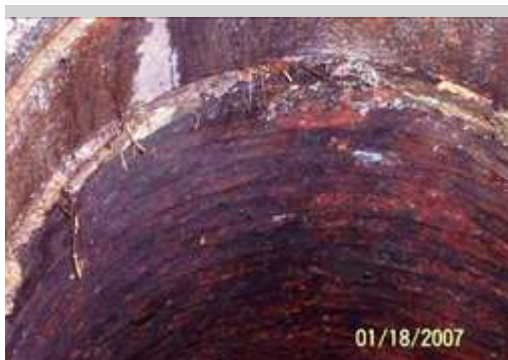
Defect

Adjustment deterioration, root intrusion and infiltration. Corbel and Barrel infiltration.

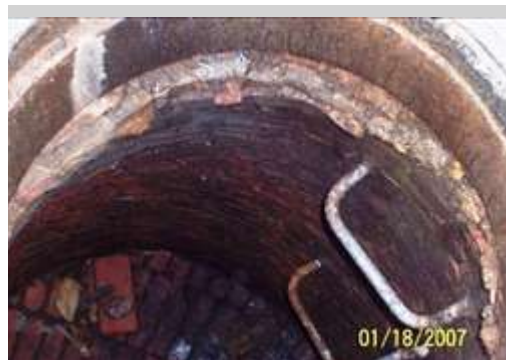
Defect

Adjustment deterioration and infiltration. Corbel and Barrel infiltration.

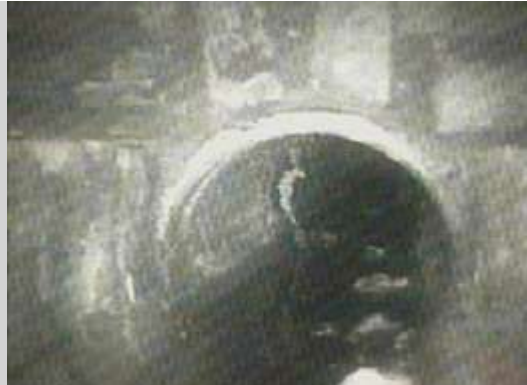
### 8 in. Circular Gravity Sewer Pipe Out @ 12 O'Clock

Deposits: ☐ None ☐ Mud ☐ Sludge ☒ **Debris** ☒ **Grease**

Silt Depth: **0** (in.) Deposits Extent: **Light**

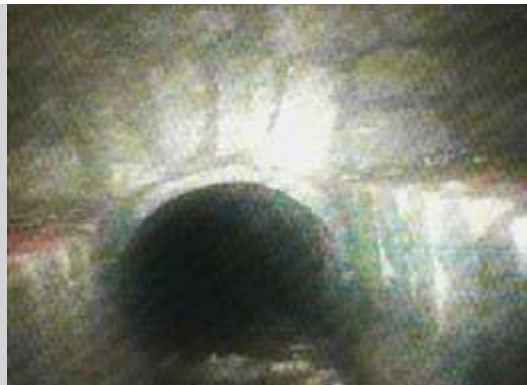
### 8 in. Circular Gravity Sewer Pipe In @ 5 O'Clock

Deposits: ☐ None ☐ Mud ☐ Sludge ☒ **Debris** ☒ **Grease**

Silt Depth: **0.5** (in.) Deposits Extent: **Light**
